## Somerleyton Hall Suffolk

Goldholme  
Stone

# Somerleyton Hall - Stone gateway restoration

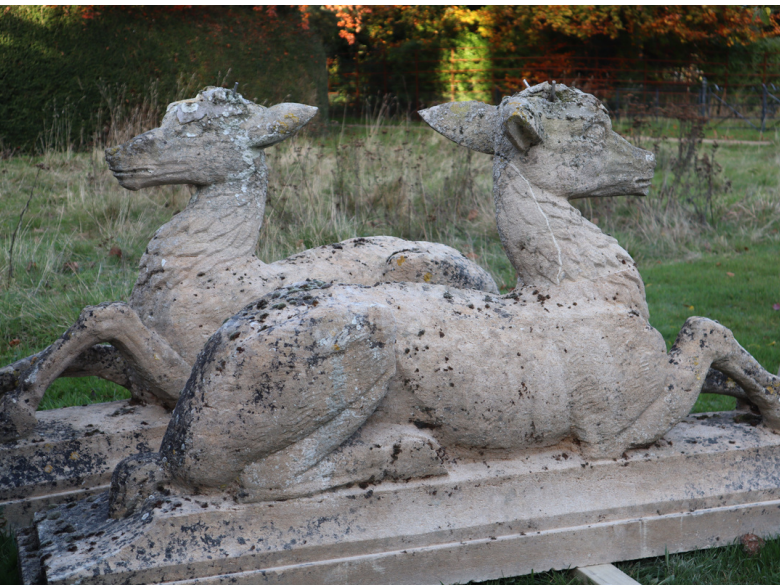
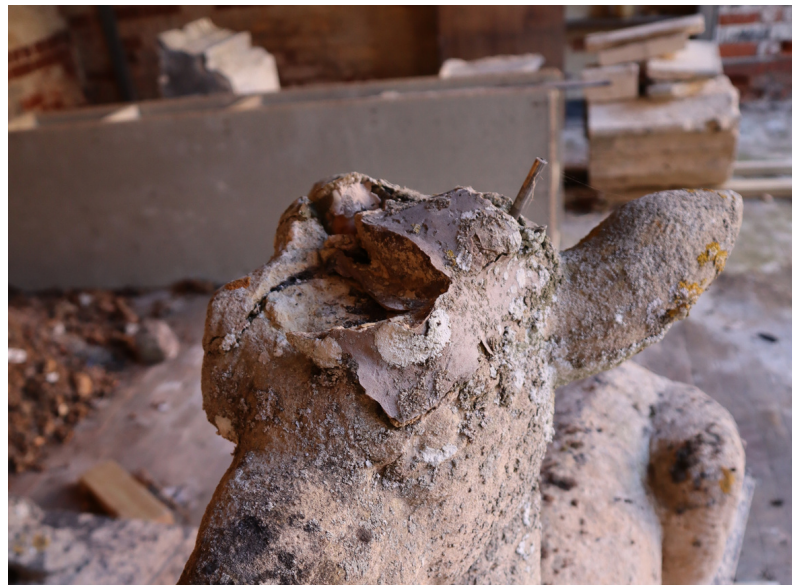
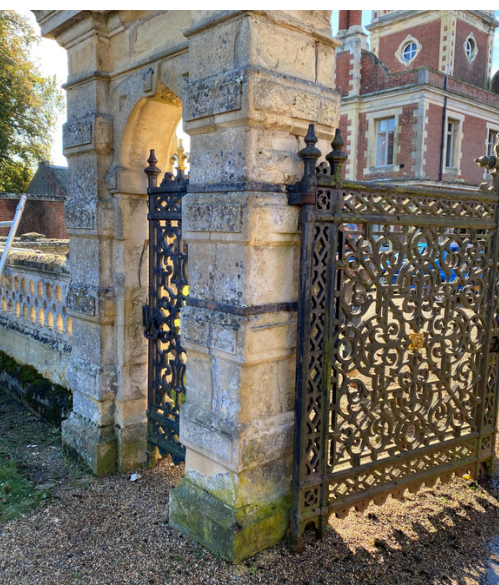
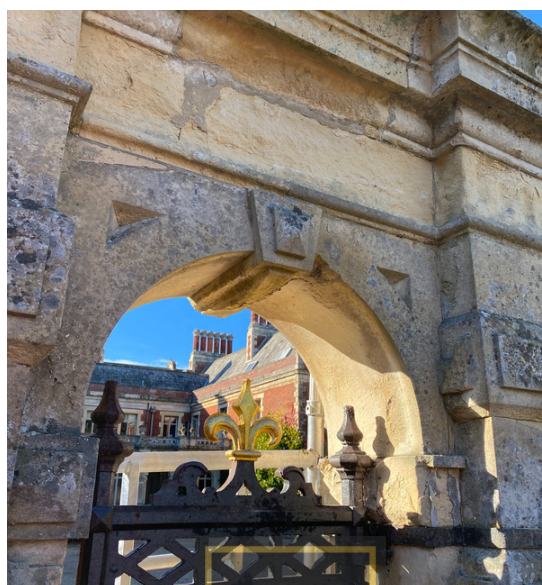
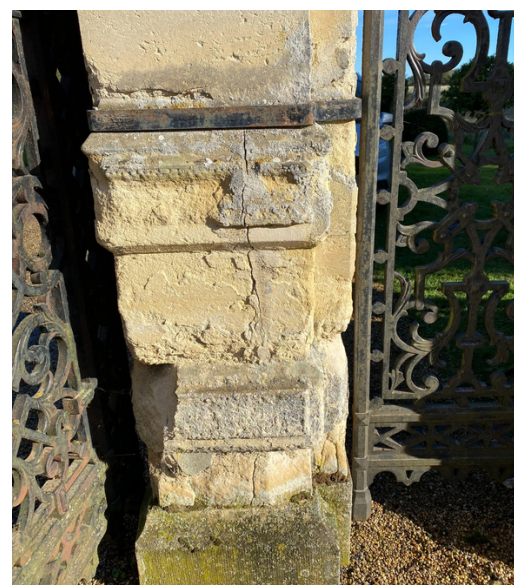
The restoration of the stone gateway at Somerleyton Hall presented several challenges. Firstly, the original French limestone, prone to substantial deterioration from chemical weathering, necessitated finding a suitable replacement material. This led to the procurement of Hartham Park Bath stone from Lovell Stone, the closest match available.

Secondly, the statues of stags atop the gate posts had undergone crude repairs with cement mortar, endangering the integrity of their antlers. Additionally, the gate's column had suffered damage from an unfortunate accident involving a lorry.

To address these issues, the restoration process involved expert disassembly of the gateway using traditional mason hand tools, followed by careful storage of carved statues and stone elements to be retained. State-of-the-art technology, including saws and robots, was utilized at the Ancaster quarry to cut replacement stones based on precise measurements taken from the existing gateway.

Furthermore, the restoration included the refurbishment of the cast iron parts of the gates and the installation of a new automatic system.

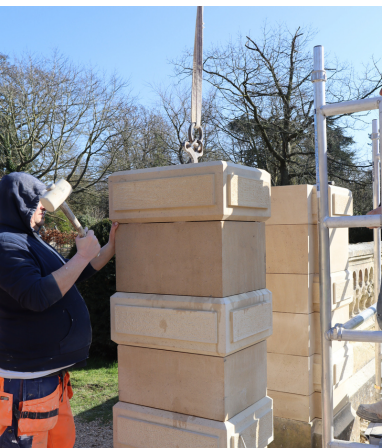
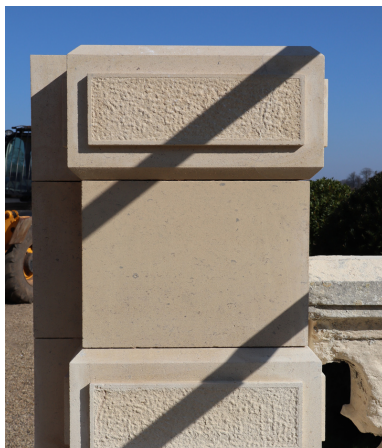
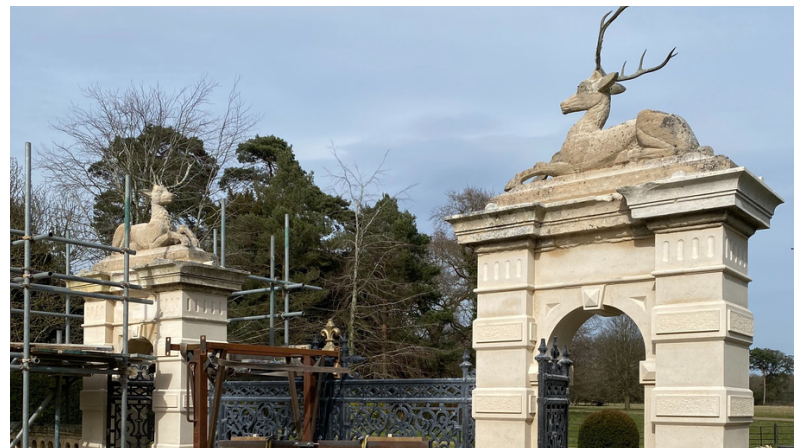
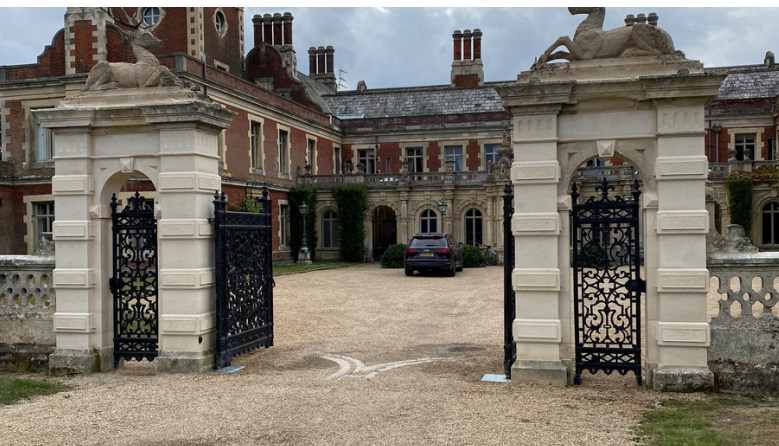
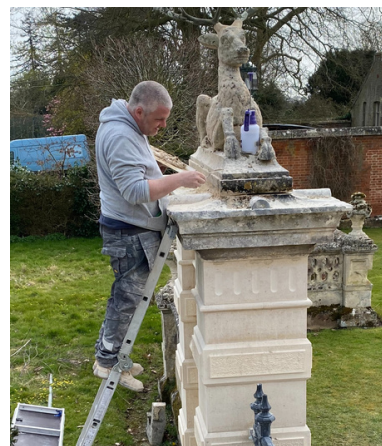
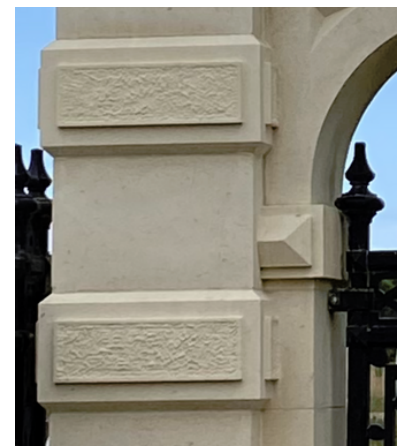
Our Head Mason created drawings by measuring the existing gateway and utilized our advanced saw and robot at our quarry in Ancaster to cut the replacement stone. The original gates were made from materials transported in the 18th century through the English Channel from France, but due to depleted reserves, a search for a suitable replacement was initiated. The closest match found was Hartham Park Bath stone, sourced from Lovell Stone.

The gateway was carefully dismantled using traditional mason hand tools, followed by a crane to move components and safely store carved statues and stone elements that were to be preserved.

The restoration process spanned several months, enduring various English weather conditions, with the final reassembly in Spring 2022.
